ARBORIST REPORT-
Tree Survey & Recommendations for:

Student Services Building
3535 Truman Avenue
Mountain View, CA
November 4, 2021

Mountain View Los Altos Union High School District
1299 Bryant Avenue
Mountain View, CA 94040

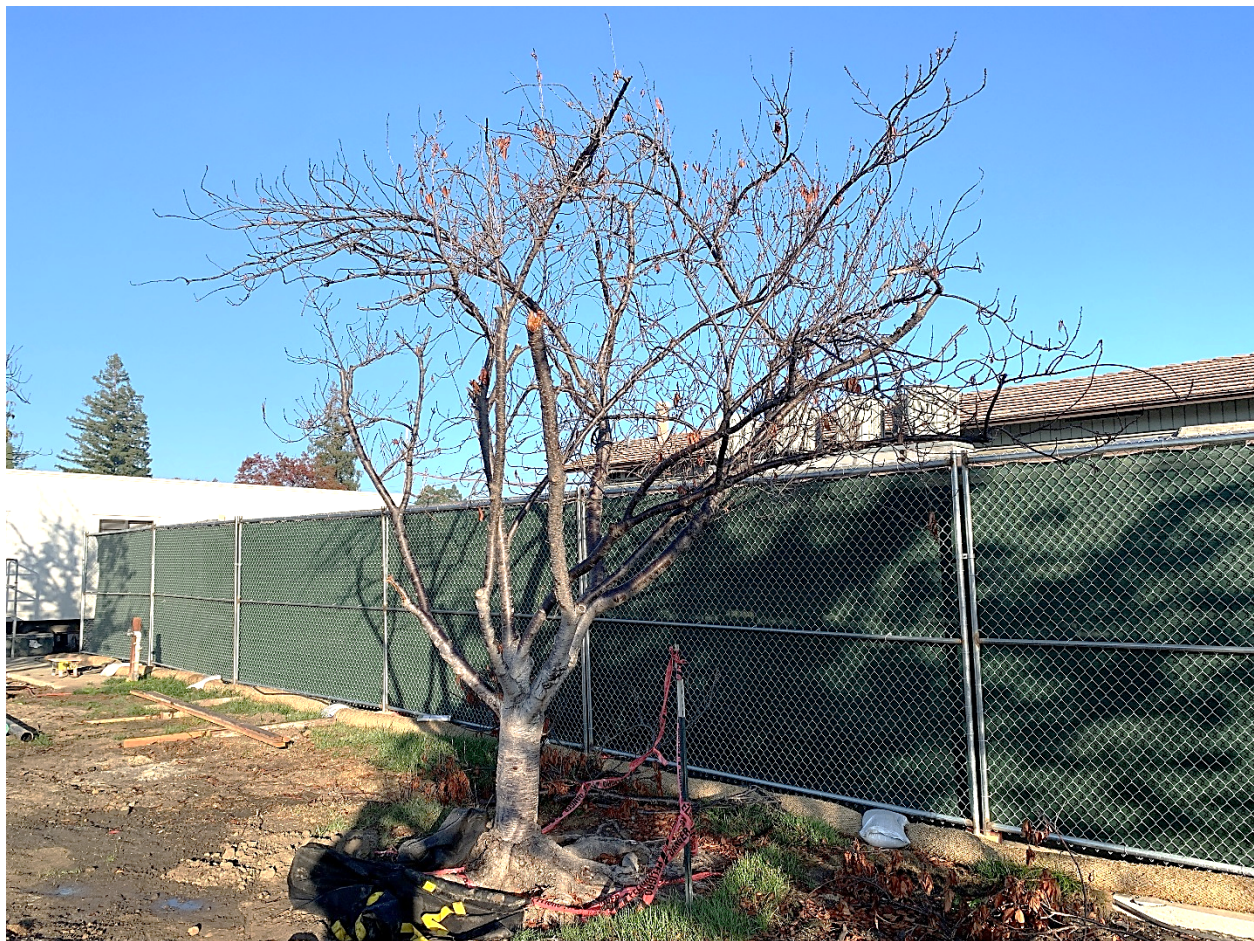
Two trees T2 & T4 were in poor condition, in a significant state of decline, and will not recover. Both are nearly dead. Tree T2, 10" diameter, is shown below, (Image #1).

Image #1 - Tree T2, a 10" diameter, cherry tree.

1. Remove cherry trees T1, T2, T3 and T4.
2. Remove soil where roots were cut at cherry tree T5, back to where roots are in good condition and bark is intact. Cleanly prune roots with a Sawzall or another sharp tool. Backfill soil to cover cut roots.
3. After construction is completed, replant four cheery trees of the same species to retain the current landscape scheme and match existing trees.

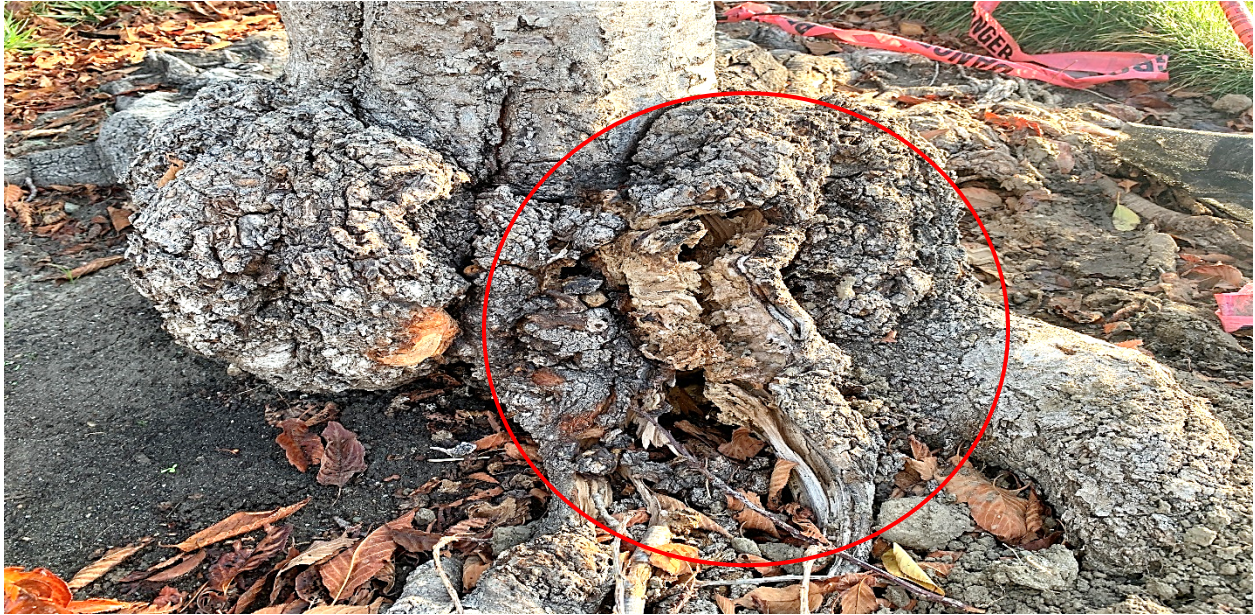
Tree T2 tree has significant buttress root decay, (Images #2 & 3)

Image #2 - Tree T2, cherry tree. Note decay, (circled).

Where decay has progressed, associated roots have died reducing the trees ability to uptake water. I scraped the bark in several locations and there was no live cambium layer. The tree has a minimal amount of live tissue.

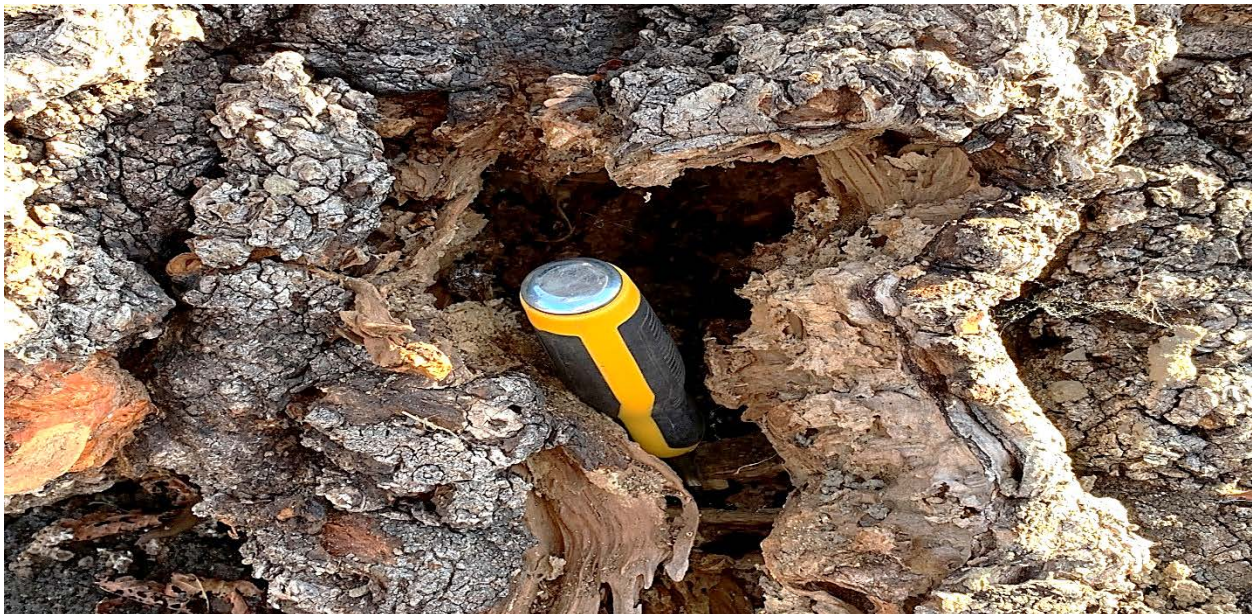
Image #3 - Tree T2, cherry tree. The decay has progressed into the lower trunk area creating a significant cavity.

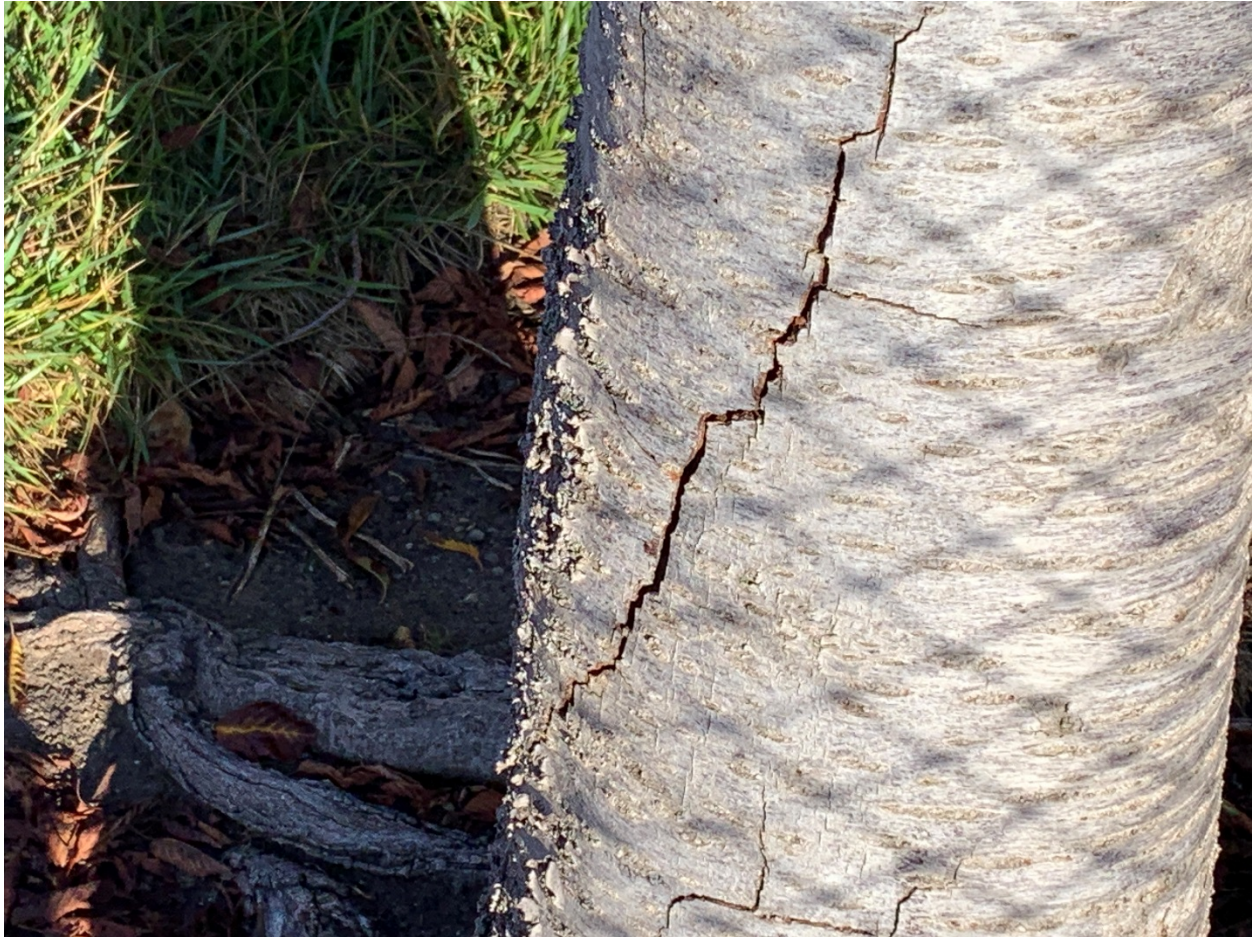
Cherry tree T4, (10" diameter), was in significant decline. The bark was splitting on the trunk, (Image #4).

Image #3 - Tree T2, cherry tree. Note splitting bark.

The bark was also splitting at the attachment point of the primary scaffolds, (limbs). The cambium layer at the split is brown color, (green is live), and dead.

I scraped the bark in several locations and there was no live cambium layer. The tree has a minimal amount of live tissue.

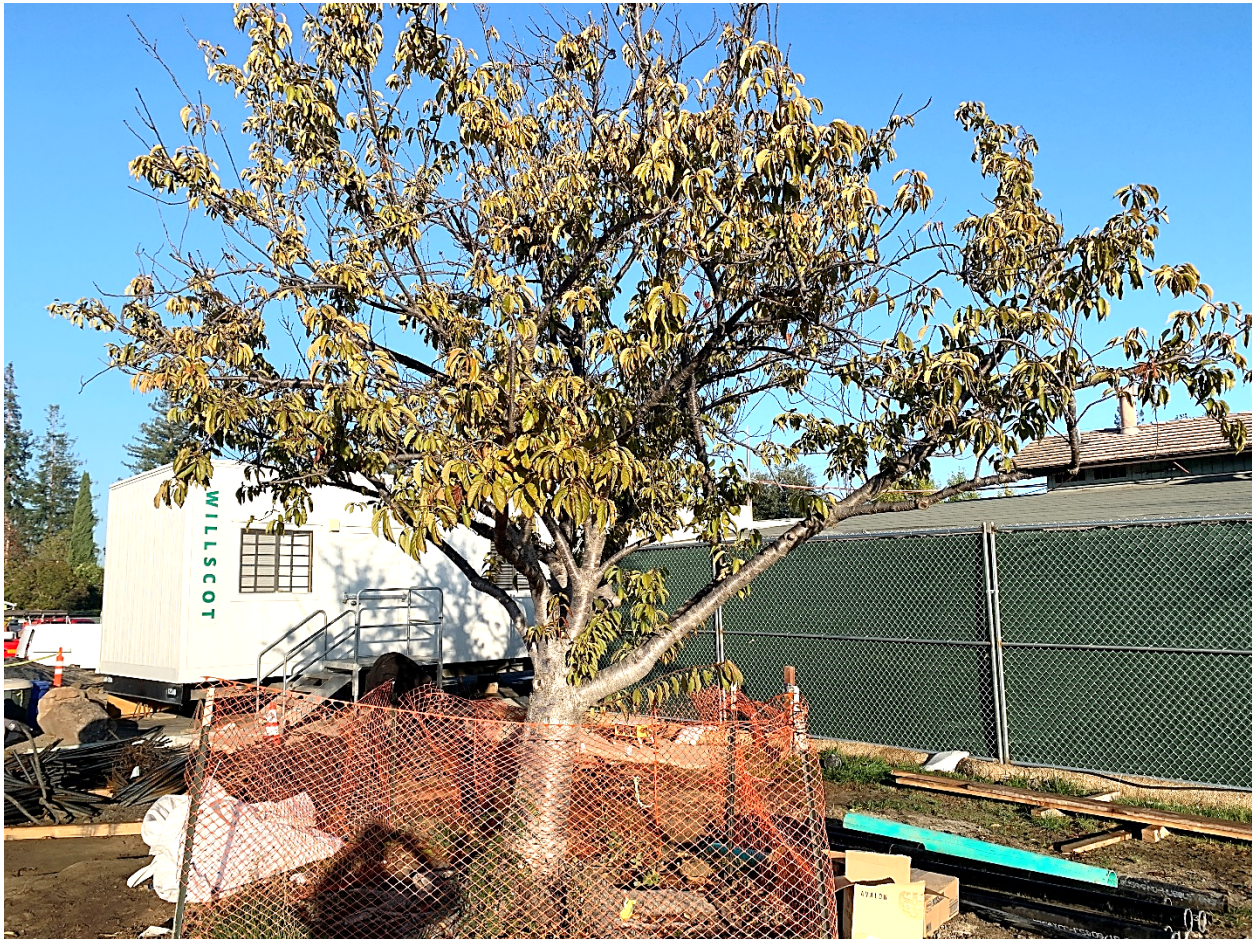
Tree T1, (12" diameter), was in fair condition, (Image #4).

Image #4 – Tree T1, cherry.

Leaves in the canopy were drooping and have lost color. Some areas had dropped leaves. Since it is fall season, it is difficult to discern if the leaf dropping and color loss was a seasonal pattern, or a result of a declining condition.

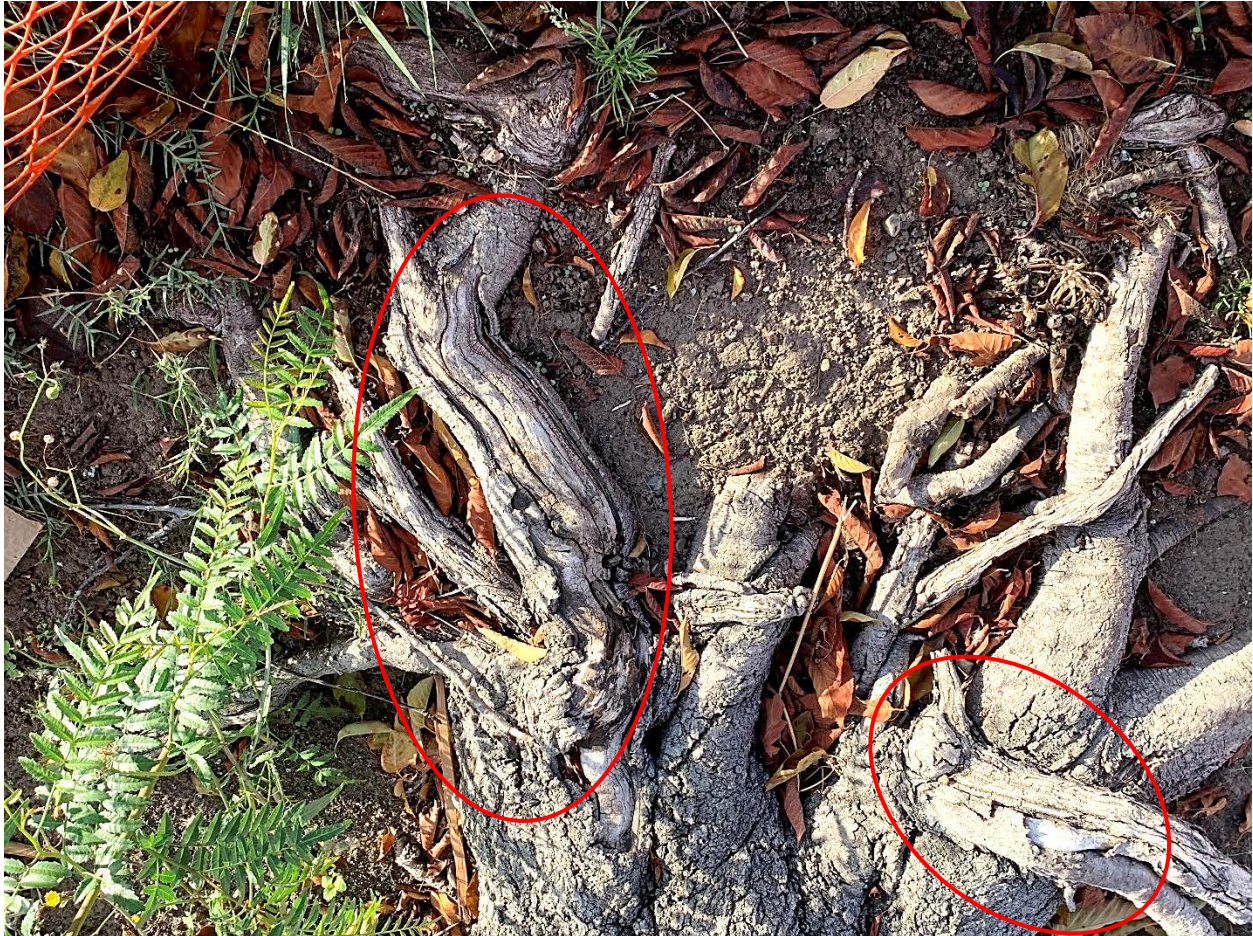
The tree has buttress root decay observed over about half of the buttress roots, and on some exposed surface roots, (Image #5).

Image #5 - Tree T1, cherry. Note root decay, (circled).

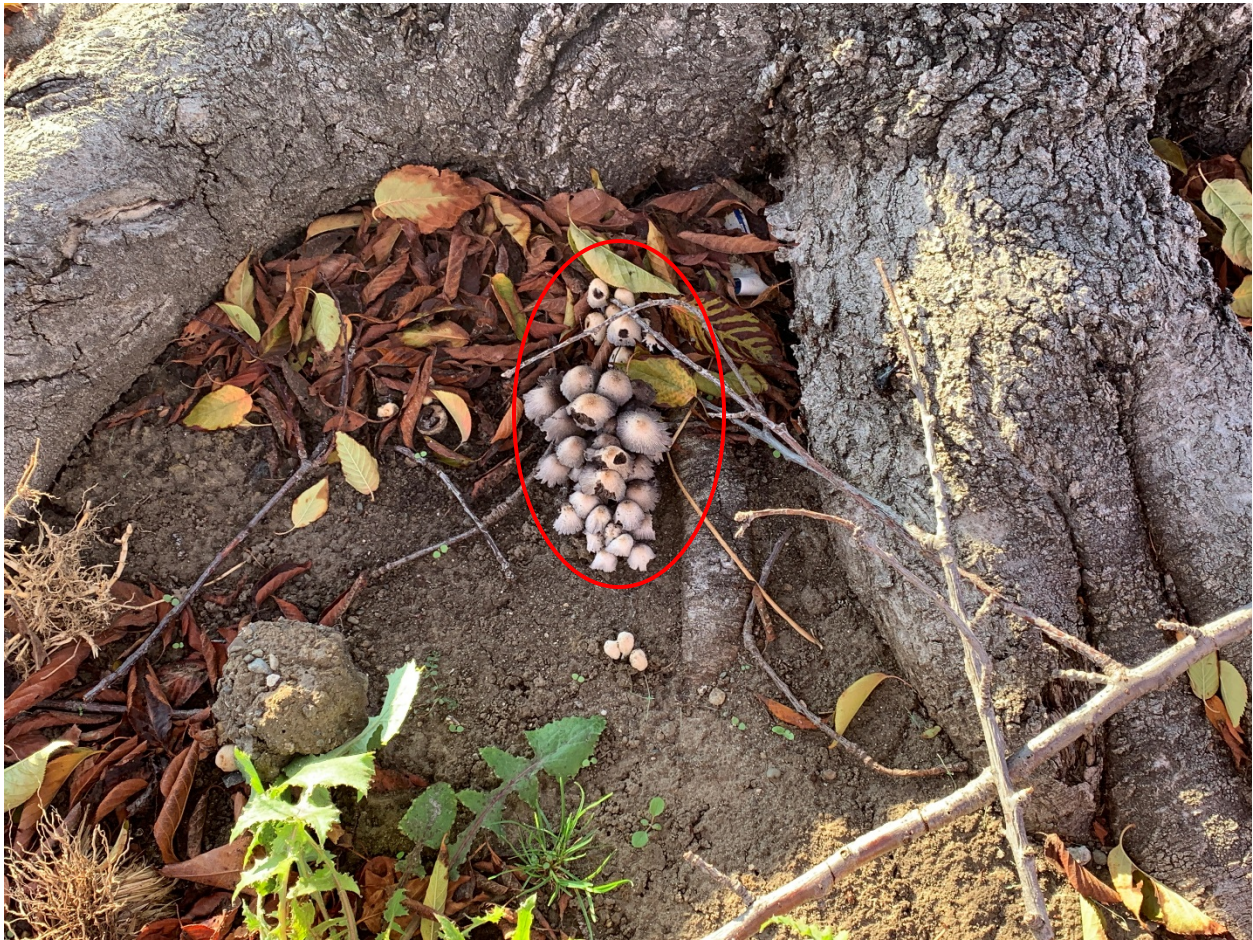
Fungal fruiting bodies were also observed adjacent to the trunk of tree T1, (Image #6).

Image #6 – Tree T1, cherry. Note fungi at tree base, (circled).

I was not able to identify the species of fungi. However, several species of fungi cause soil borne fungal diseases and root decay in trees.

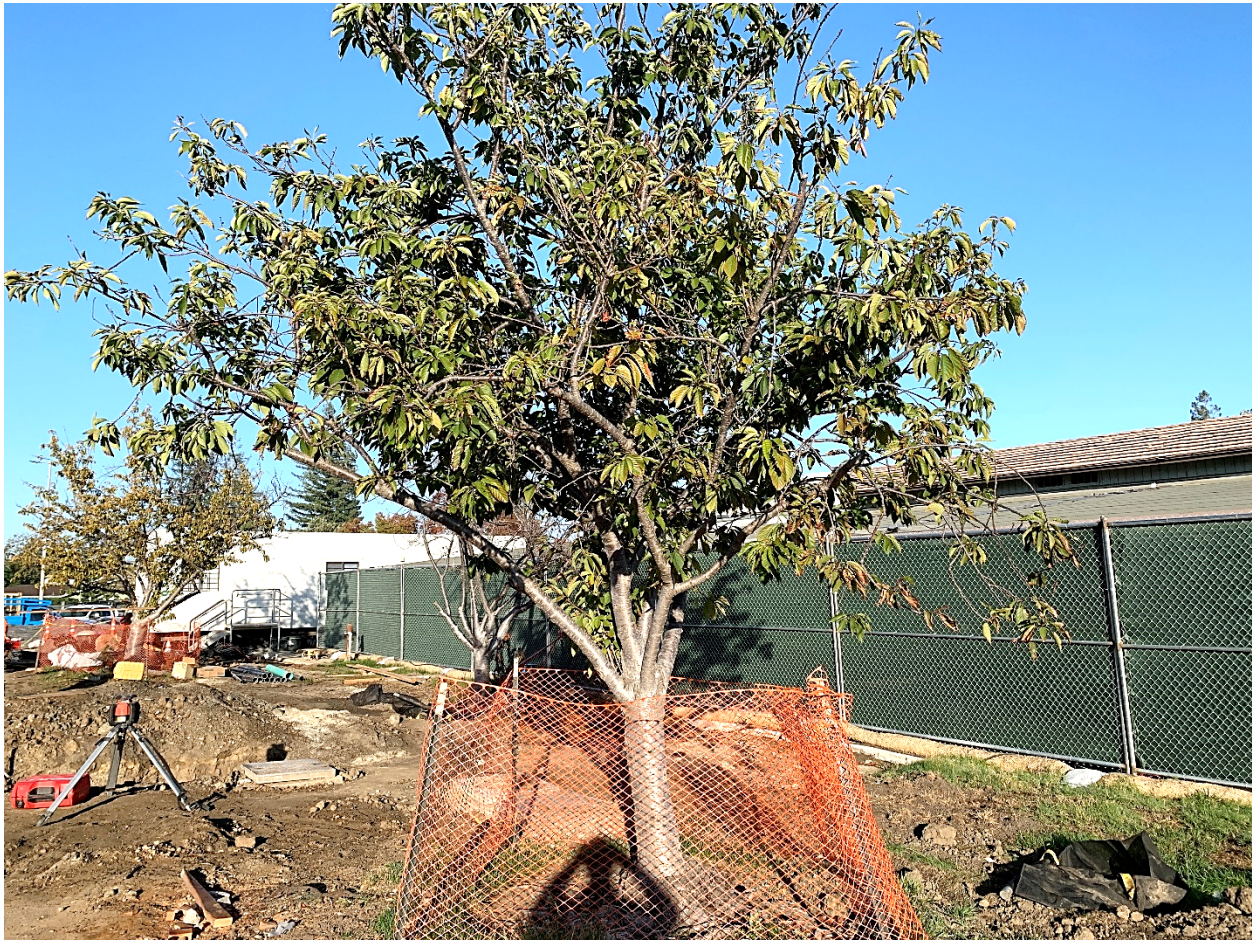
Tree T3, (10" diameter), was in fair condition, (Image #7).

Image #7, - Tree T3, cherry.

The leaf canopy density and color is in a normal condition.

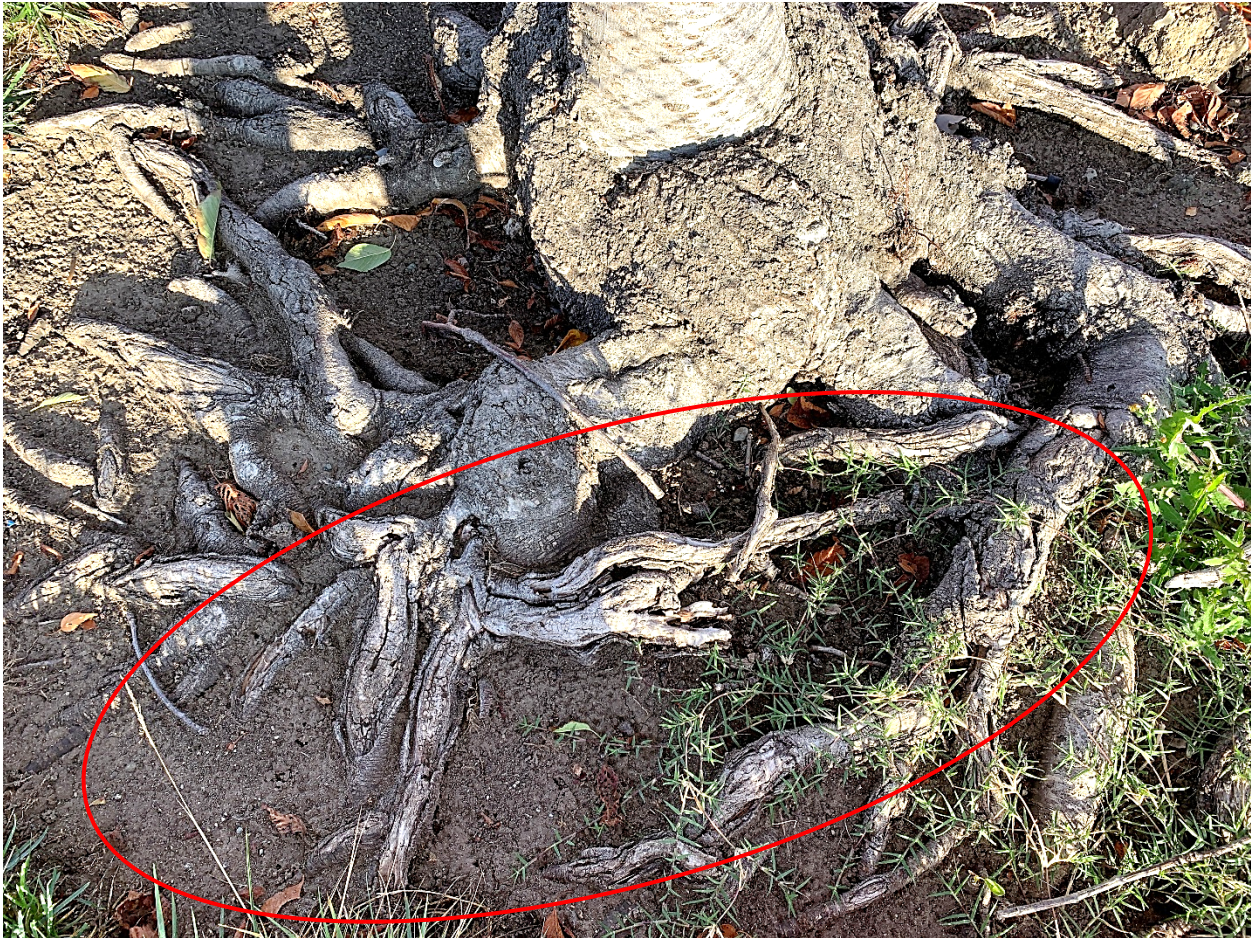
Cherry tree T3 has deadwood and decay over about half of its surface roots, (Image #8).

Image #8, - Tree T3, cherry. Note cracked and decayed roots, (circled).

Many surface roots were split and decay was visible.

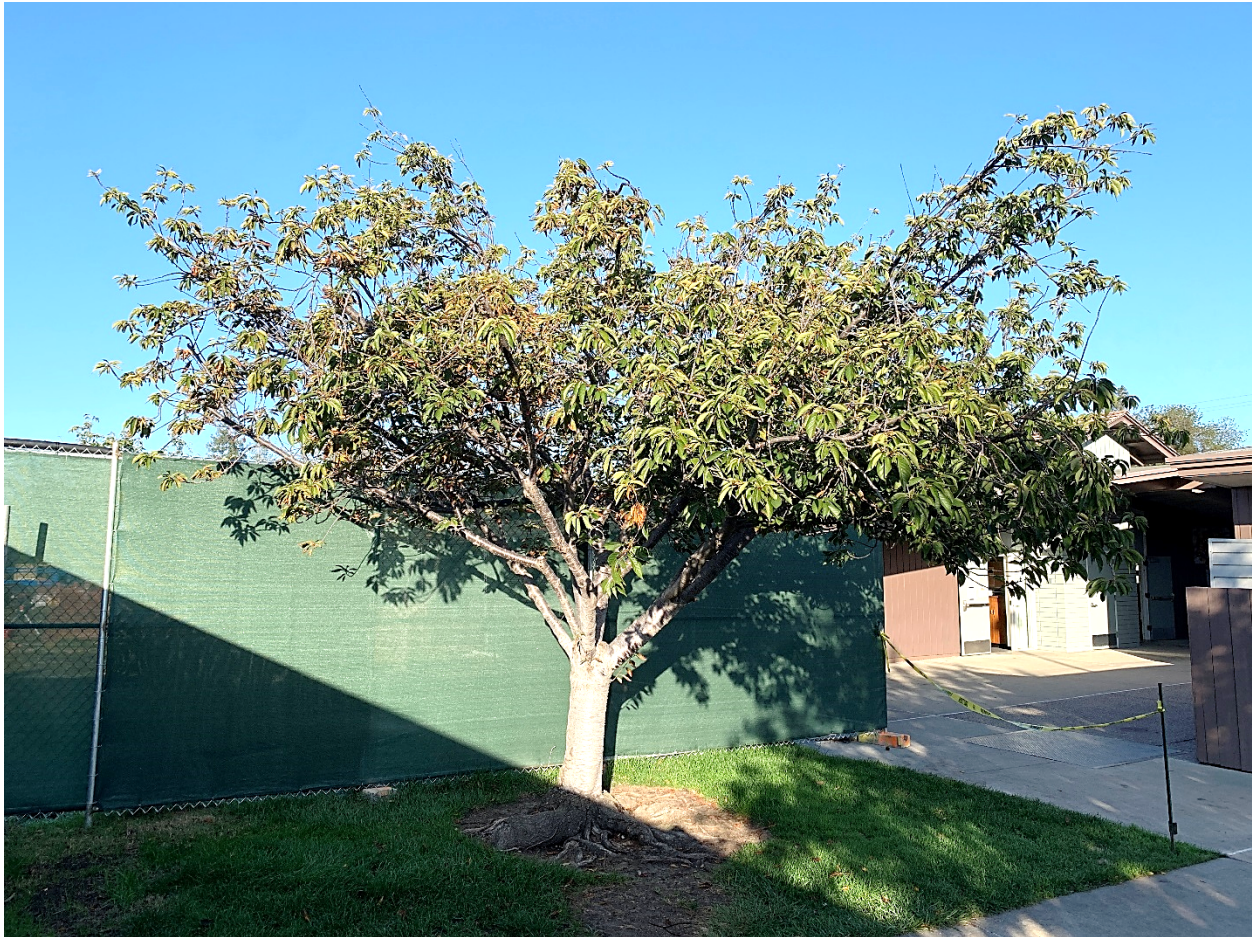
Tree T5 was in fair condition (Image #9)

Image #9, - Tree T5, cherry.

The leaf canopy density and color is in a normal condition.

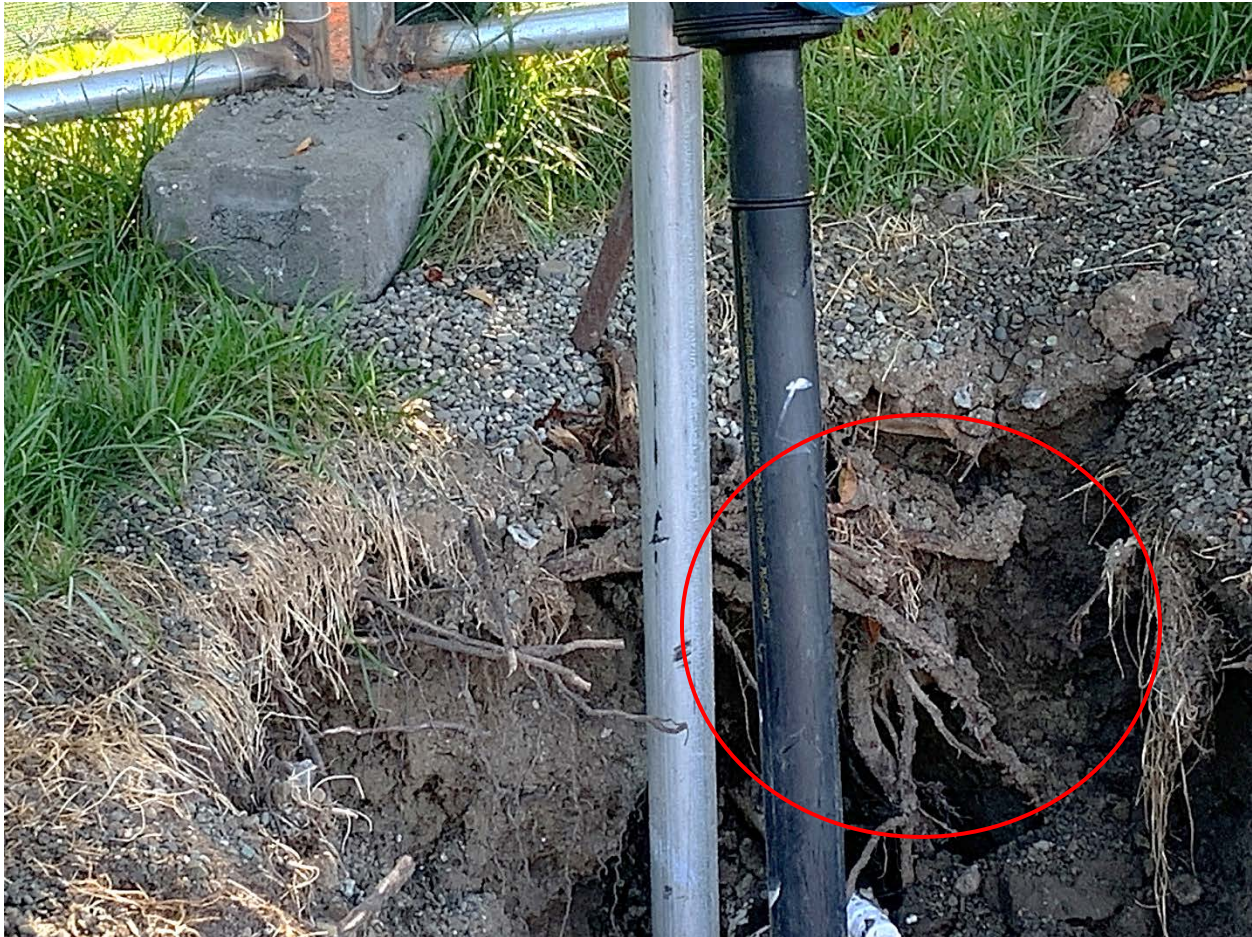
Some roots have been cut on tree T5 where a pipeline tie-in was done, (Image #10).

Image #9, - Tree T5, cherry. Several one half to 1" diameter roots were cut for tie-in, (circled).

The roots were cut 4-5 feet from the tree trunk.

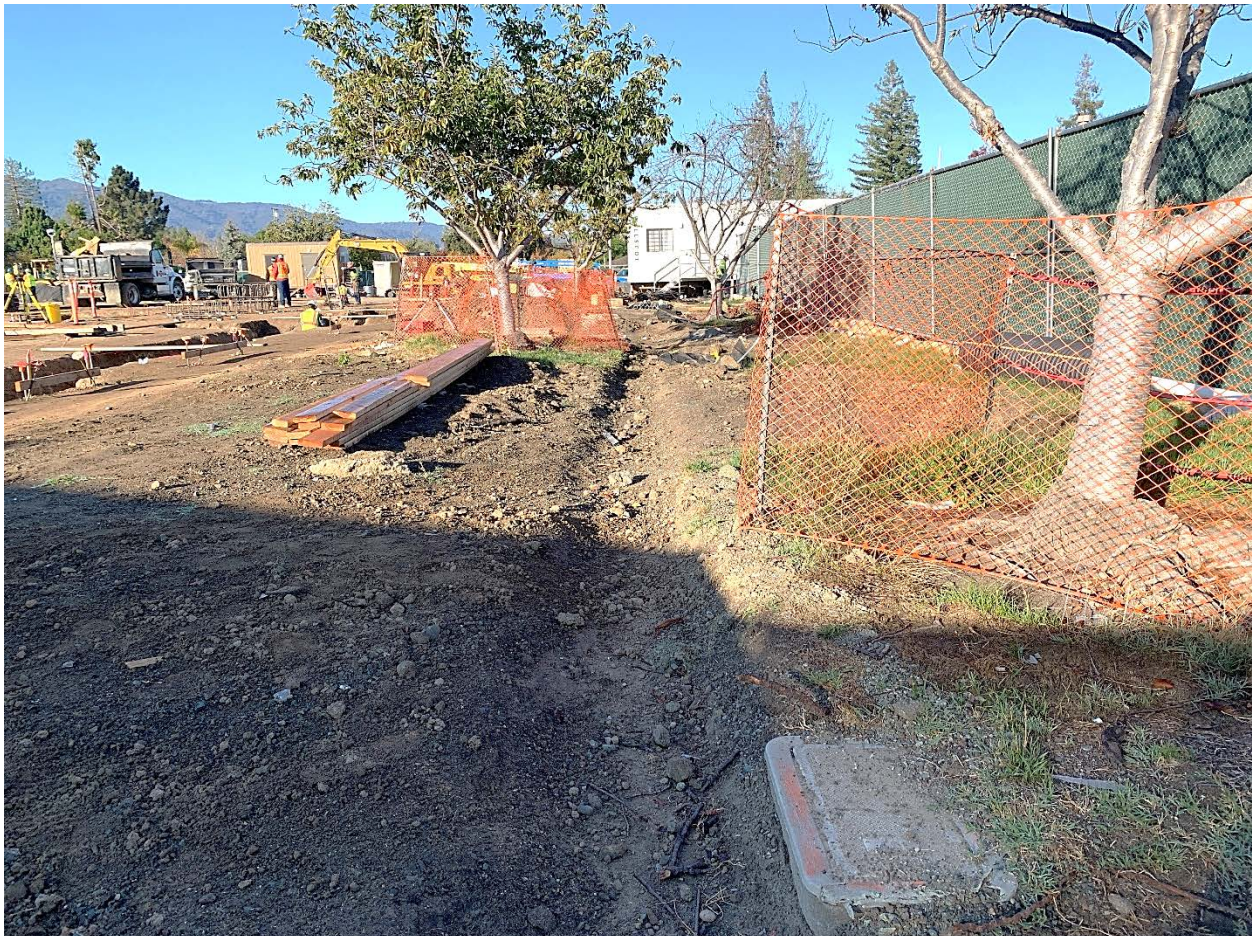
Four of the five cherry trees have root decay. All five trees have been impacted to varying degrees by the construction activity. The construction impacts include root loss from the pipeline installation, (Image #8), and soil compaction from foot traffic and machinery within the trees root zone.

Image #10, - Trees T1, T2, T3 & T4, cherry. Note linear soil depression from pipeline installation.

The pipeline was installed within 4-feet of the cherry trees. Based on the distance of root disturbance from the trees, root losses from this work is estimated at moderate to significant.

Discussion with the onsite foreman indicated that two additional pipelines will be installed in the same trench. This is likely to cause additional root loss.

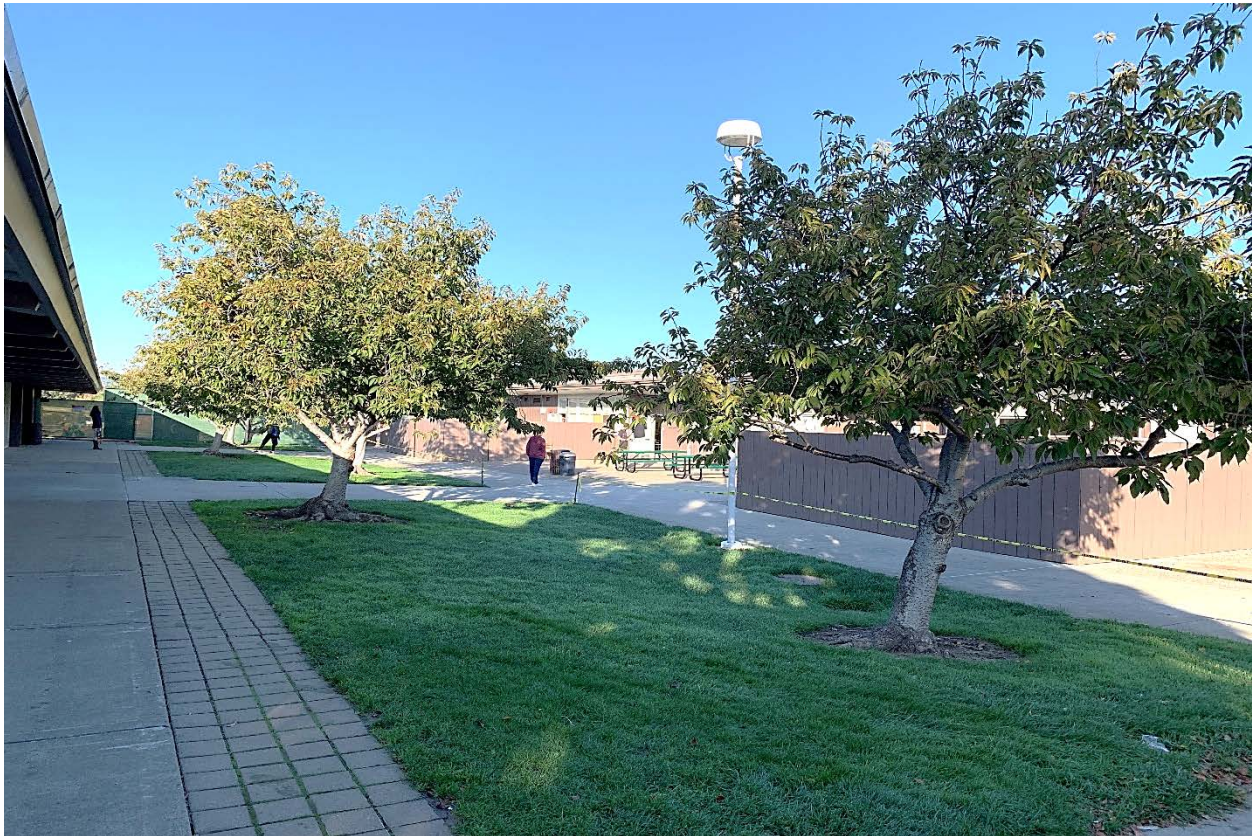
Image #11 – Cherry trees outside project limits.

The cherry trees outside the project limits have denser foliar canopies and have not yet dropped leaves. These trees also do not show root decay in the surface roots.
